(NASA-CR-120184) LINEAR TEST BED.
VOLUME 1: TEST BED NO. 1 Final Report
(Rocketdyne) 252 p HC \$15.75 CSCL 14B

LINEAR TEST BED
FINAL REPORT
VOLUME I: TEST BED NO. 1

30 August 1972

Rocketdyne Engineering
Canoga Park, California

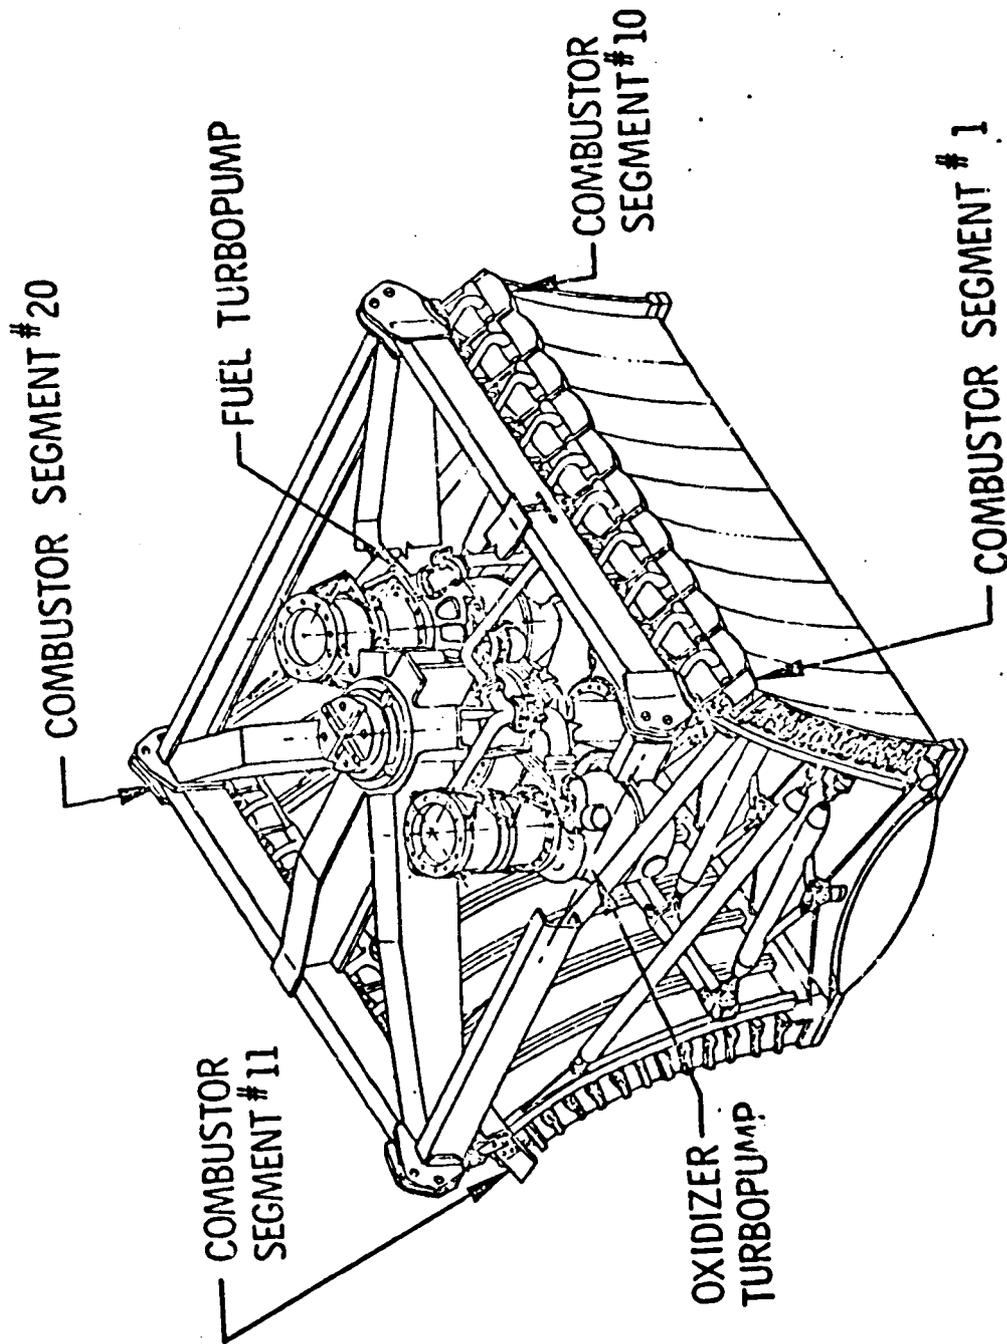
Figure 1. Test Bed

The thrust chamber assembly consists of 20 combustors, 2 nozzle assemblies, a turbine exhaust base manifold, and the supporting rib structure and tie linkages. The combustors are made from precision investment-cast NARloy (silver-copper alloy) which undergoes a process in which nickel is electroplated to the outside of the liner to provide coolant channel closeout and for structural purposes. An aluminum

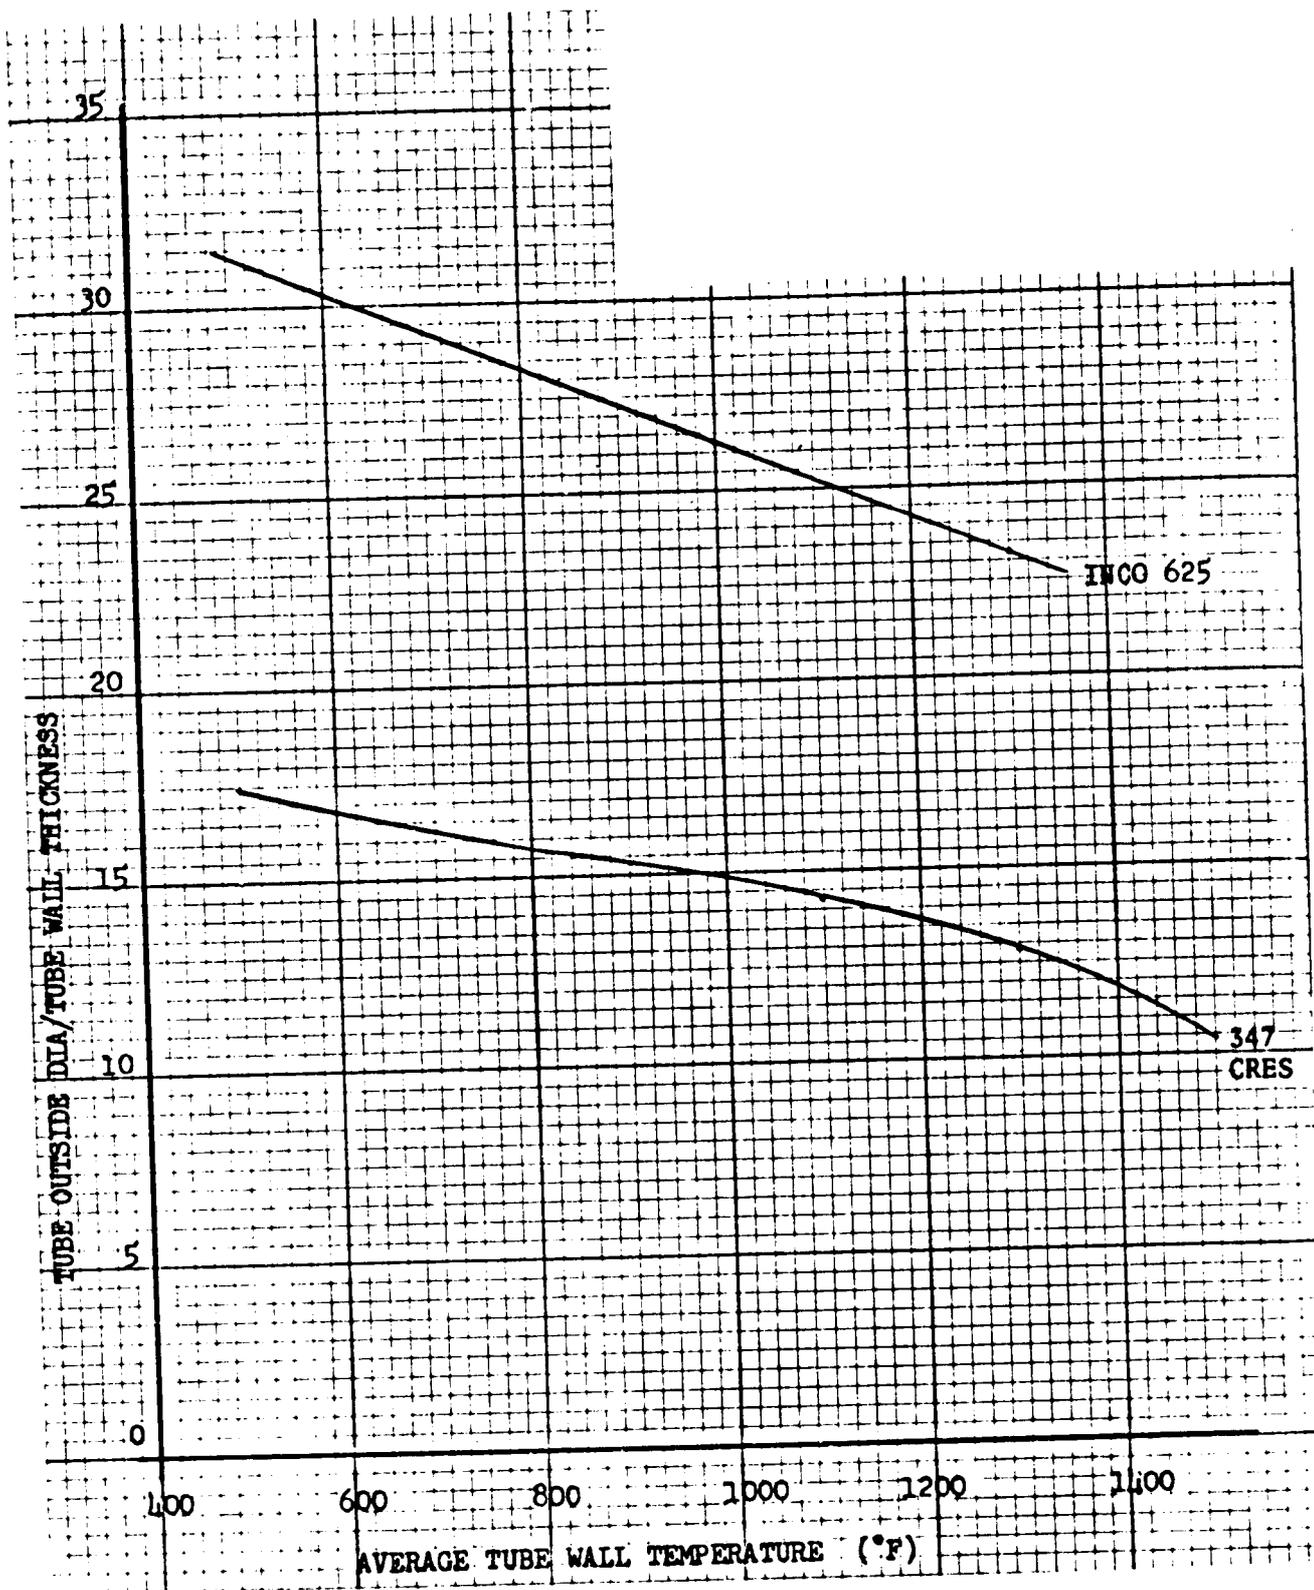
Figure 24. Lines of Maximum OD/T_w for 347 CRES and INCO 625 With 2160-psia Internal Pressure

The gas-side heat transfer coefficients were calculated for the nozzle contour specified. The technique used is similar to the Bartz boundary layer analysis. The coolant-side heat transfer film coefficients were calculated according to the McCarty¹ correlation. The point of maximum heat transfer coefficient is where the combustor and tube bundle are joined. Using the above heat transfer coefficients, the tube size was determined to be 0.200 inch for the diameter and 0.015 inch wall thickness.

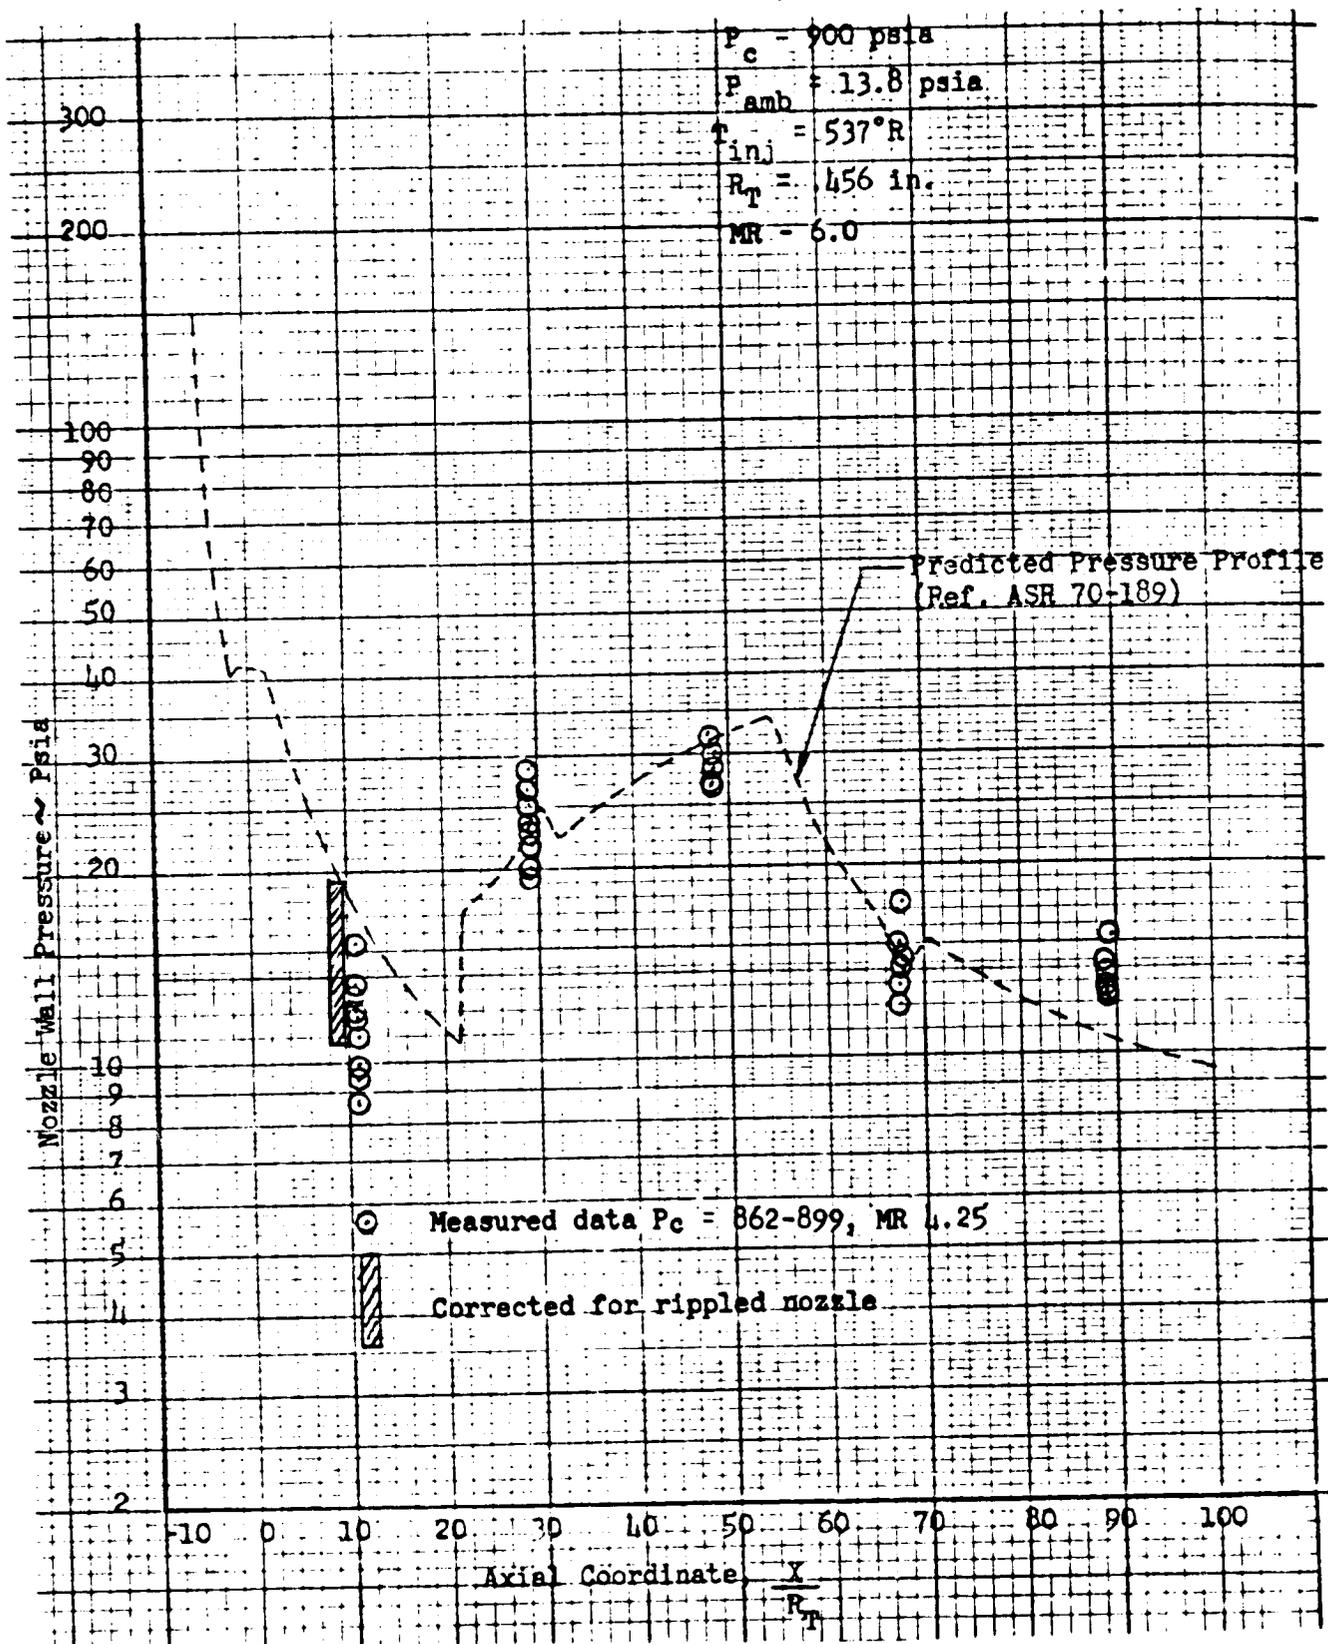
Figure 57. Breadboard Engine No. 1 Nozzle Pressure Profile

$P_c = 1200 \text{ psia}$
 $P_{amb} = 13.8 \text{ psia}$
 $T_{inj} = 537^\circ R$
 $R_T = .456 \text{ in.}$
 $MR = 610$

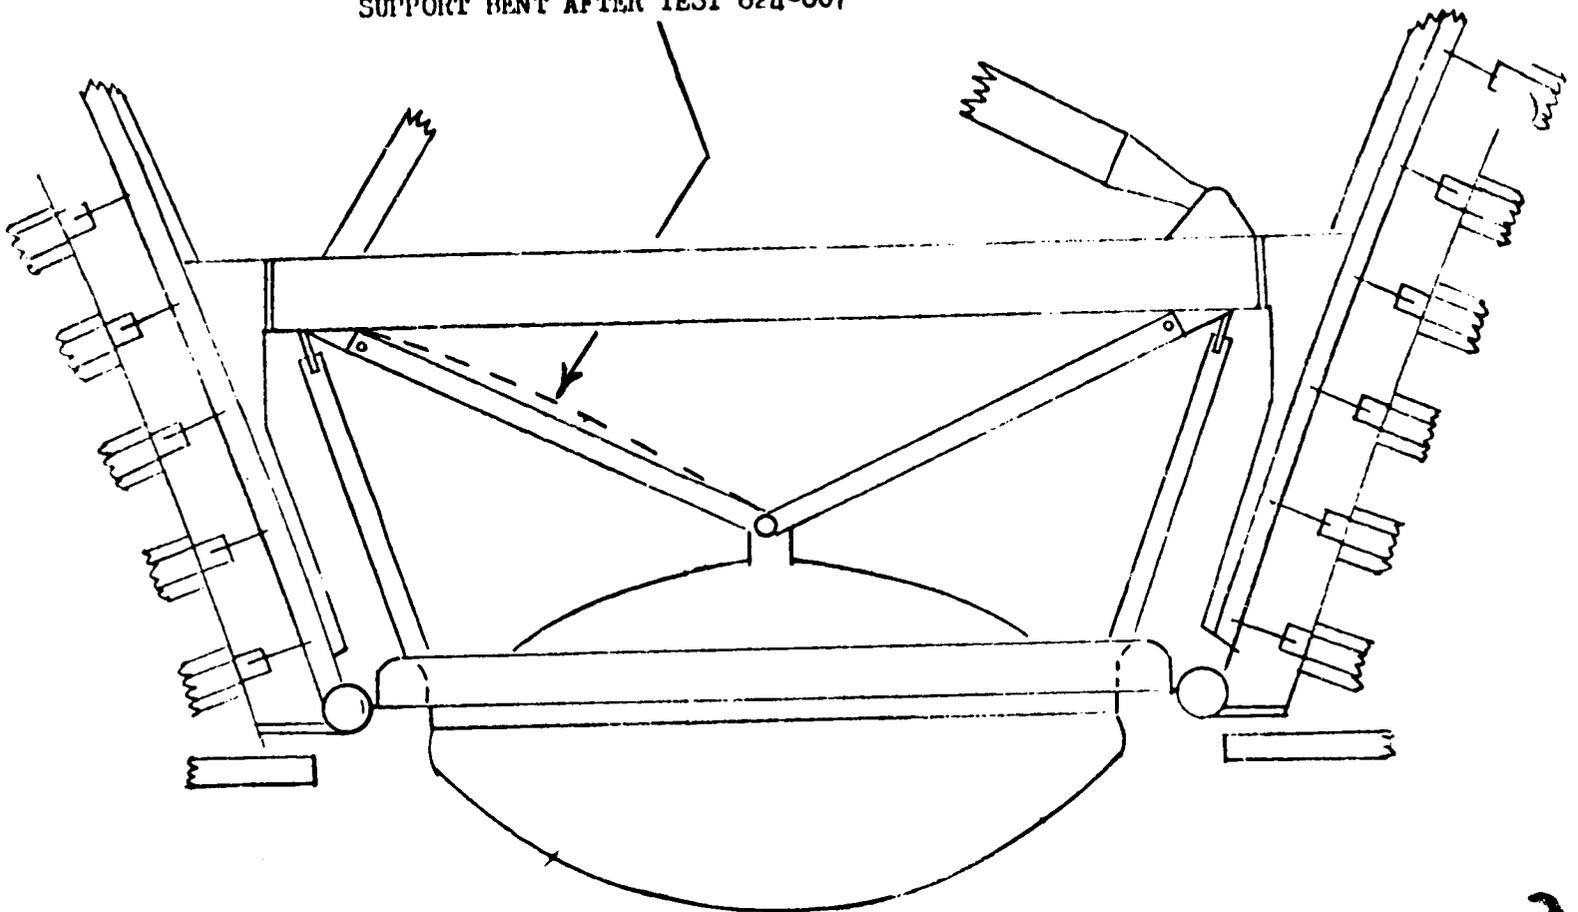
During an experimental ignition-only test (test 624-007), an open-air explosion occurred below the engine, producing deformation of both the turbine exhaust orifice plate and the base seal. The turbine exhaust orifice plate exhibited large dents with sharp radii. The base seal was deformed due to overpressure causing numerous cracks. The explosion also moved the complete turbine exhaust upward approximately 0.5 inch, bending the support members. Figure 71 illustrates the damage noted.

TURBINE EXHAUST MANIFOLD
SUPPORT BENT AFTER TEST 624-007

CRACKS AND TEARS DEVELOPED IN BASE CLOSURE SHEET
AFTER TEST 007 REQUIRING REPAIR AFTER MOST
SUBSEQUENT TESTS. TEST 028 LARGE SECTION WAS
RIPPED. NEW BASE CLOSURE SHEET WELDED IN PLACE.

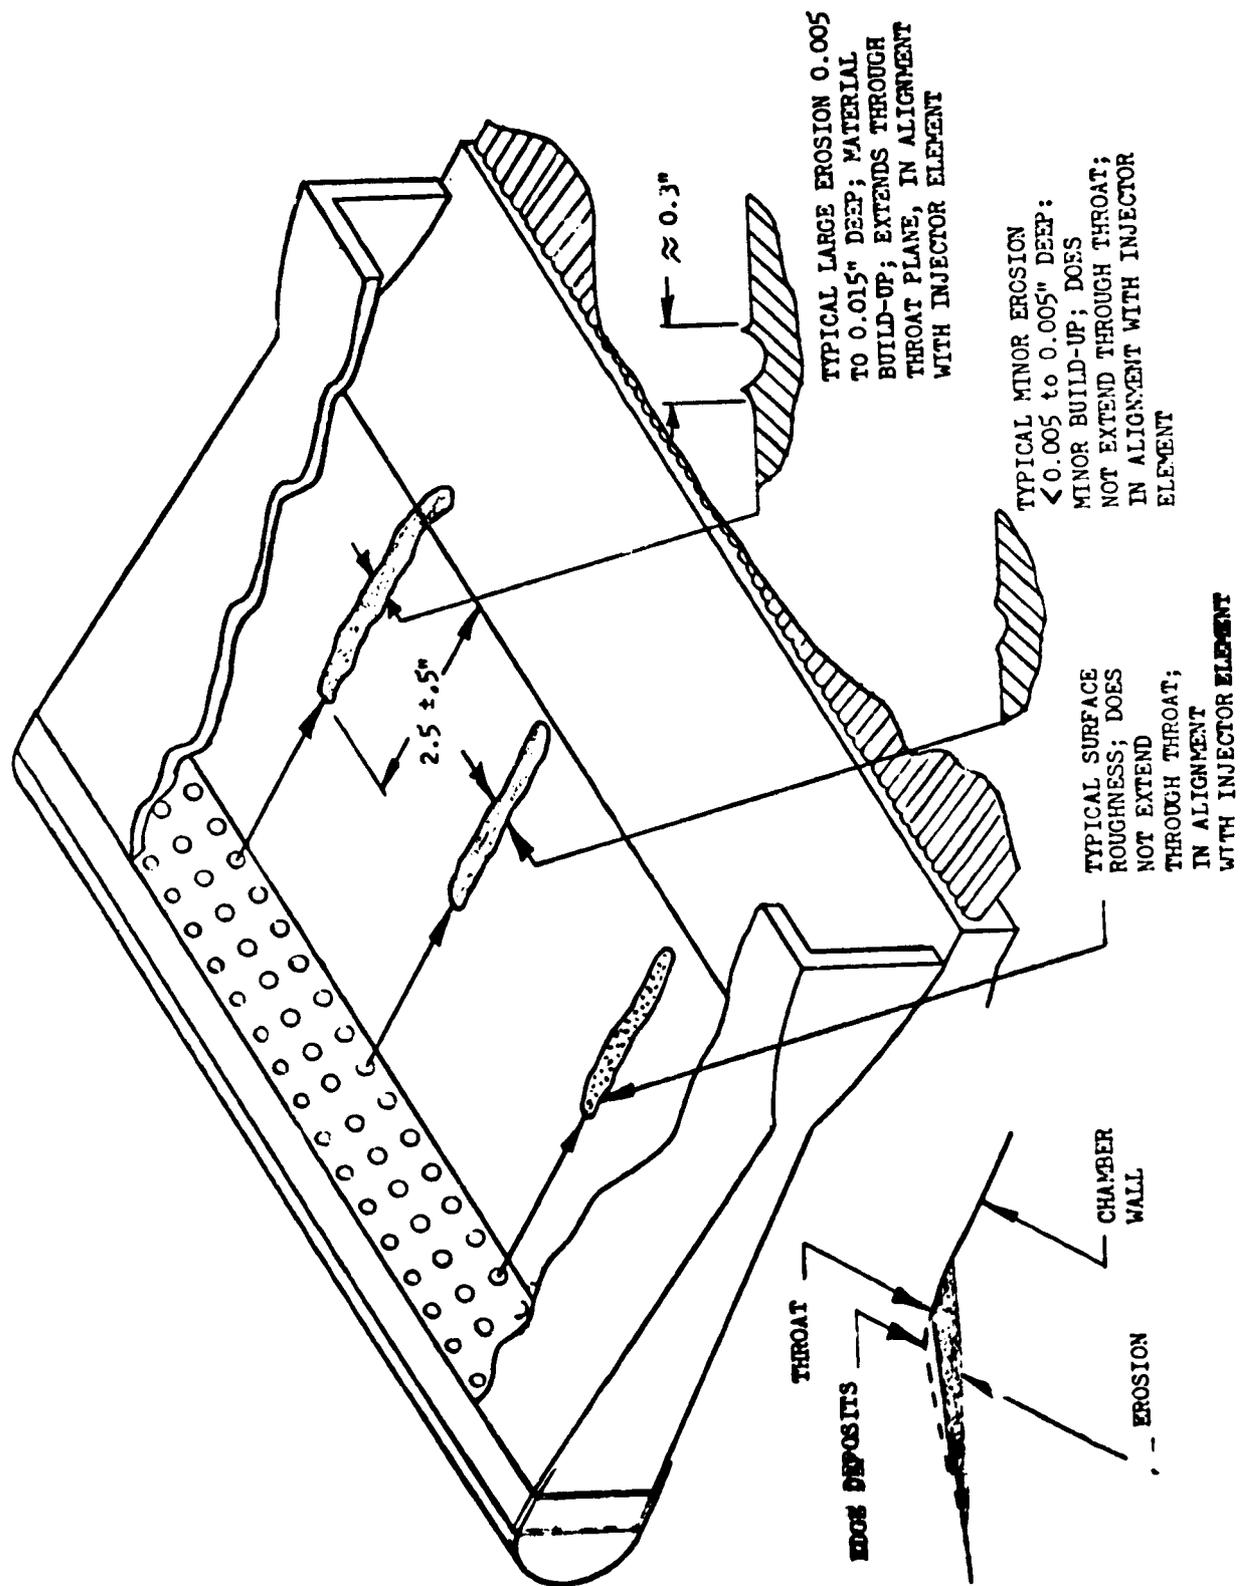
Figure 74. Combustor Wall Erosions, Breadboard No. 1

17	C-03	Smooth										Smooth									1
18	C-11	Smooth							1			Smooth									2
19	C-19	Slight Roughness	1									Slight Roughness			2						3
20	C-20	Slight		5								Slight Roughness									13
Total Erosions			15	41	27	18								11	34					4	150

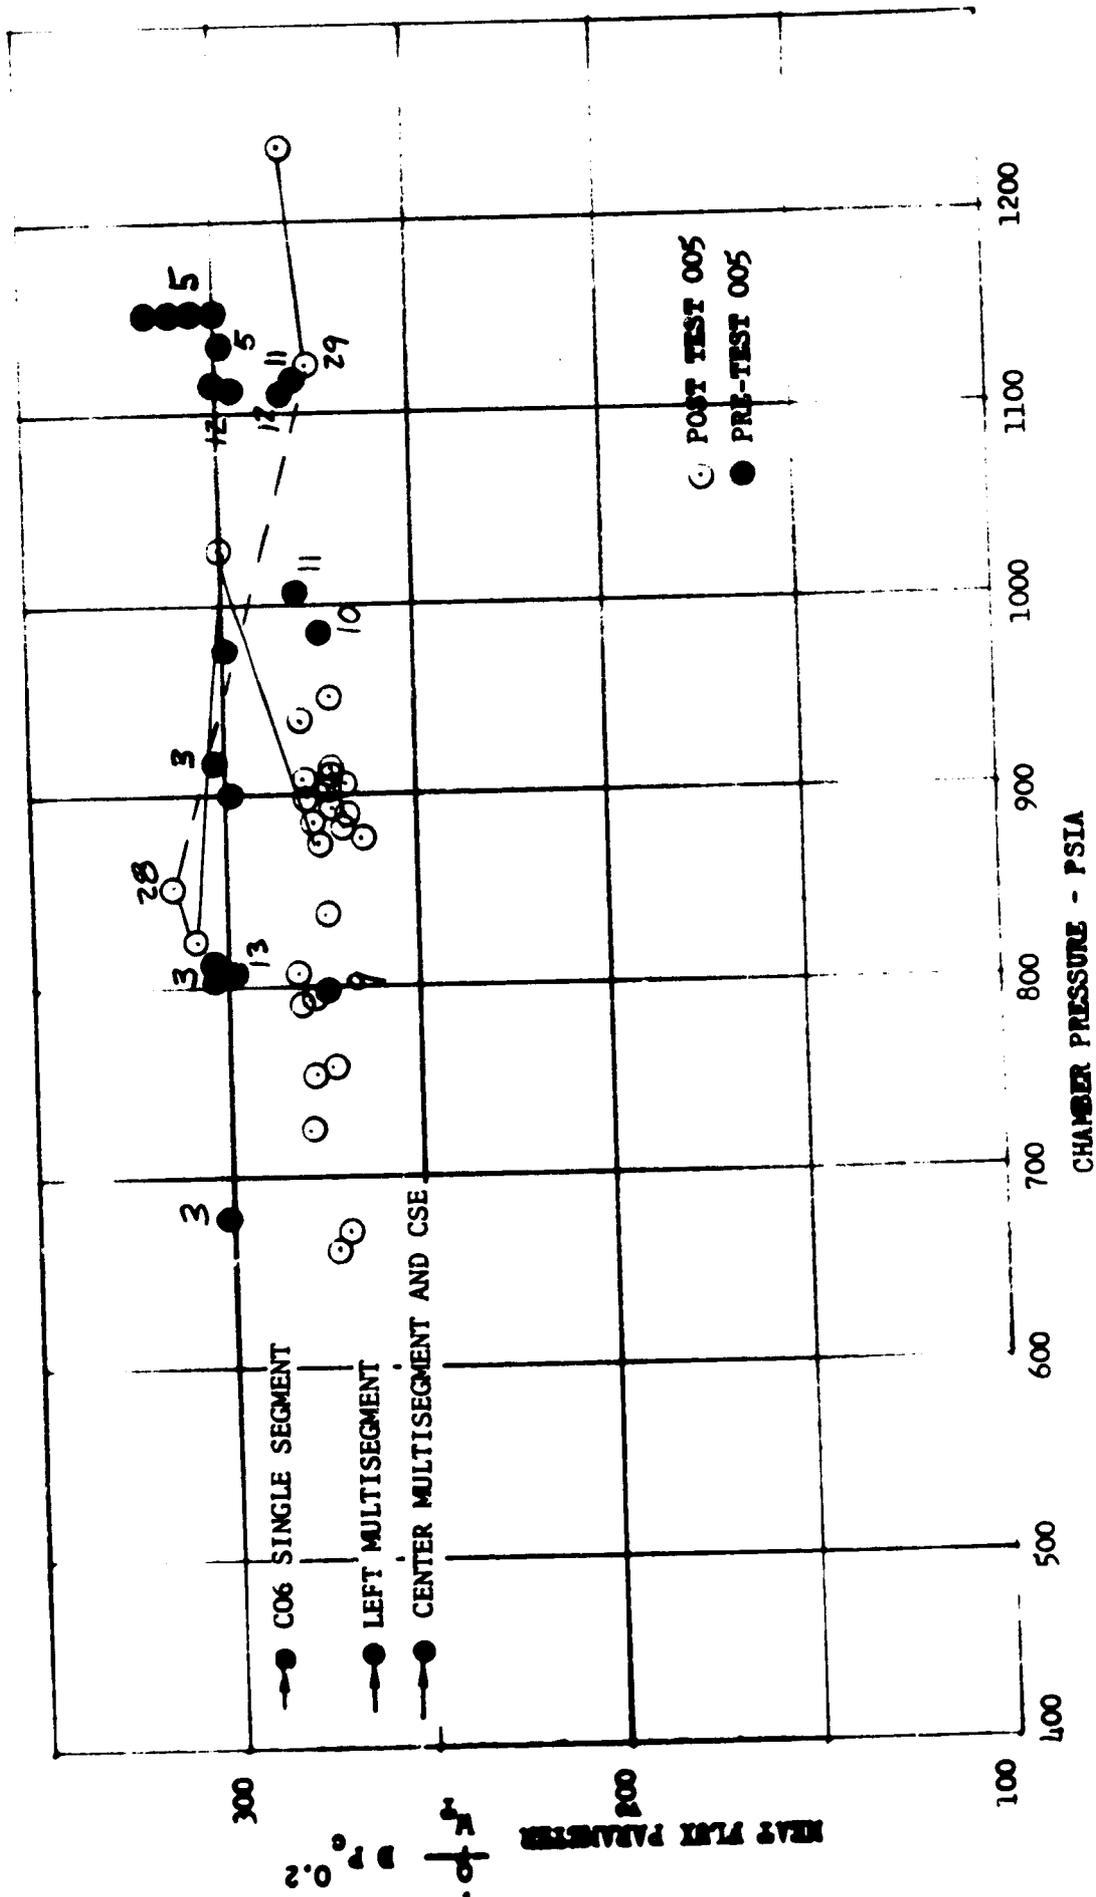
Figure 76. Linear Breadboard No. 1 Combustor Heat Flux Parameter

The heat load increased approximately 22.5 percent during the testing until the chamber erosions occurred during test 005. The first increase of significance in

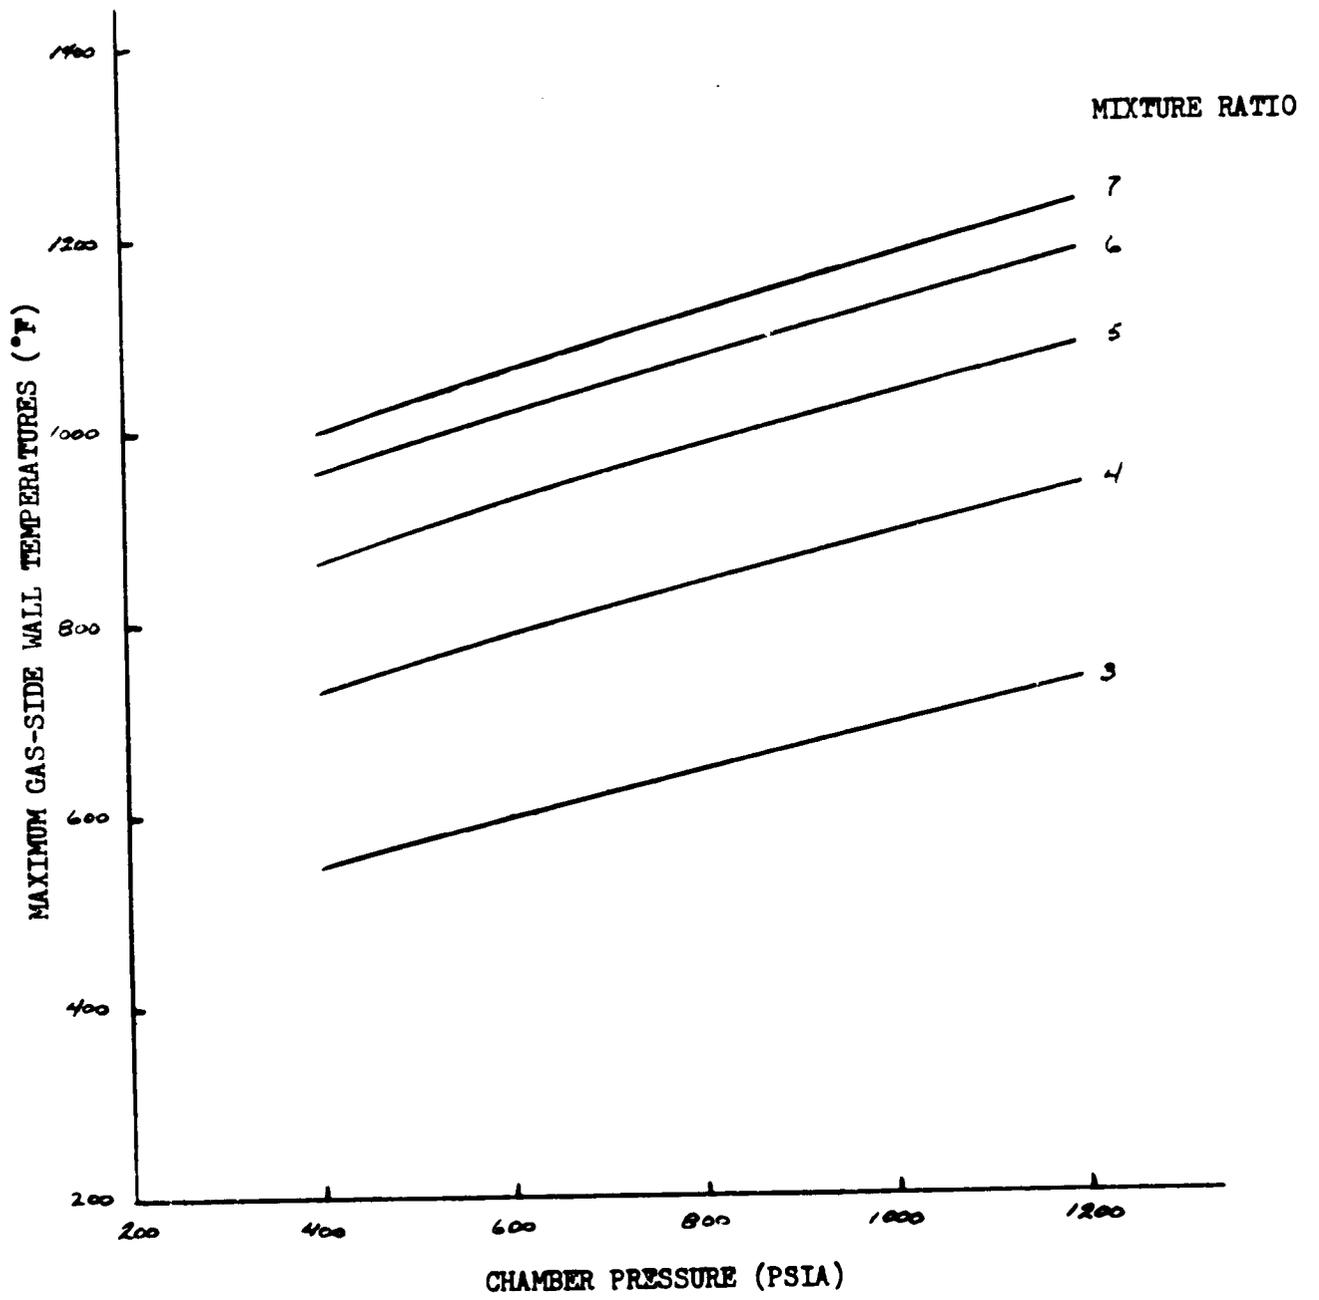
Figure 78. Theoretical Wall Temperature

The wall temperature parameter is also compared to the theoretical wall temperature determined from design values of h_g and flowrates at the chamber pressure and mixture ratio conditions of the test (Fig. 78). Six test data points were input

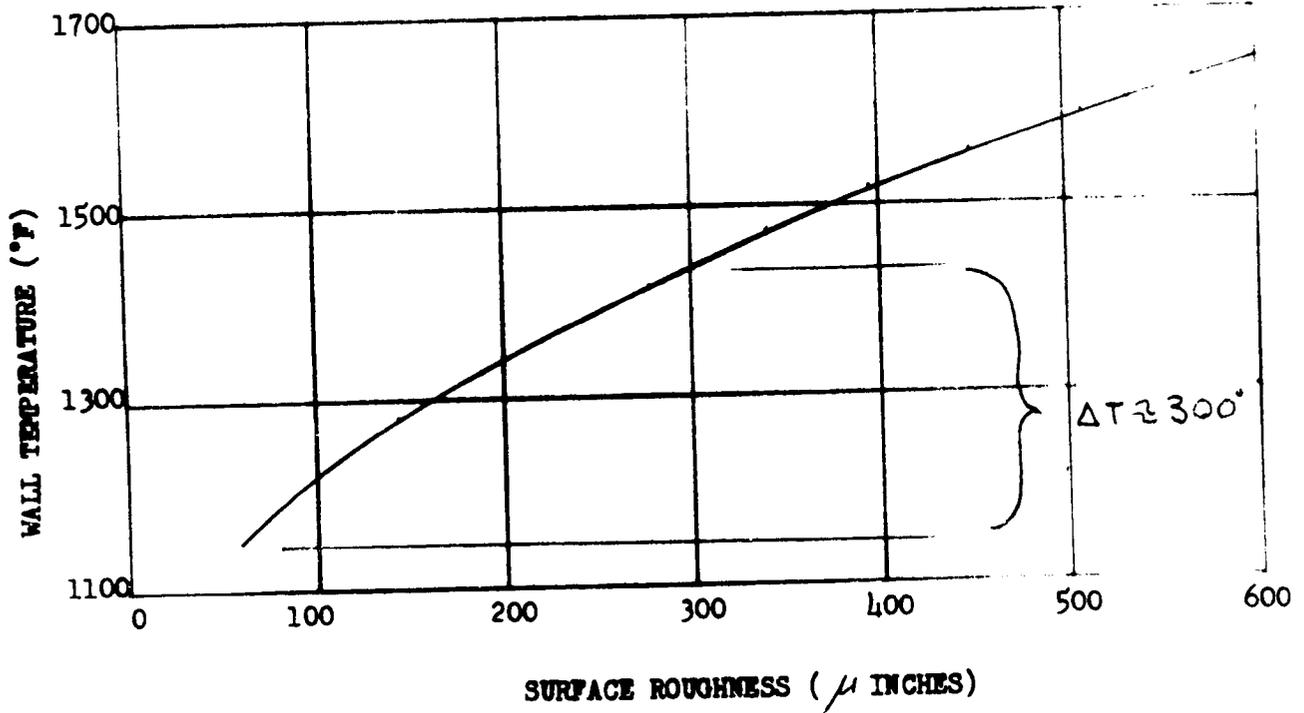
VARIATION OF h_g WITH SURFACE ROUGHNESS

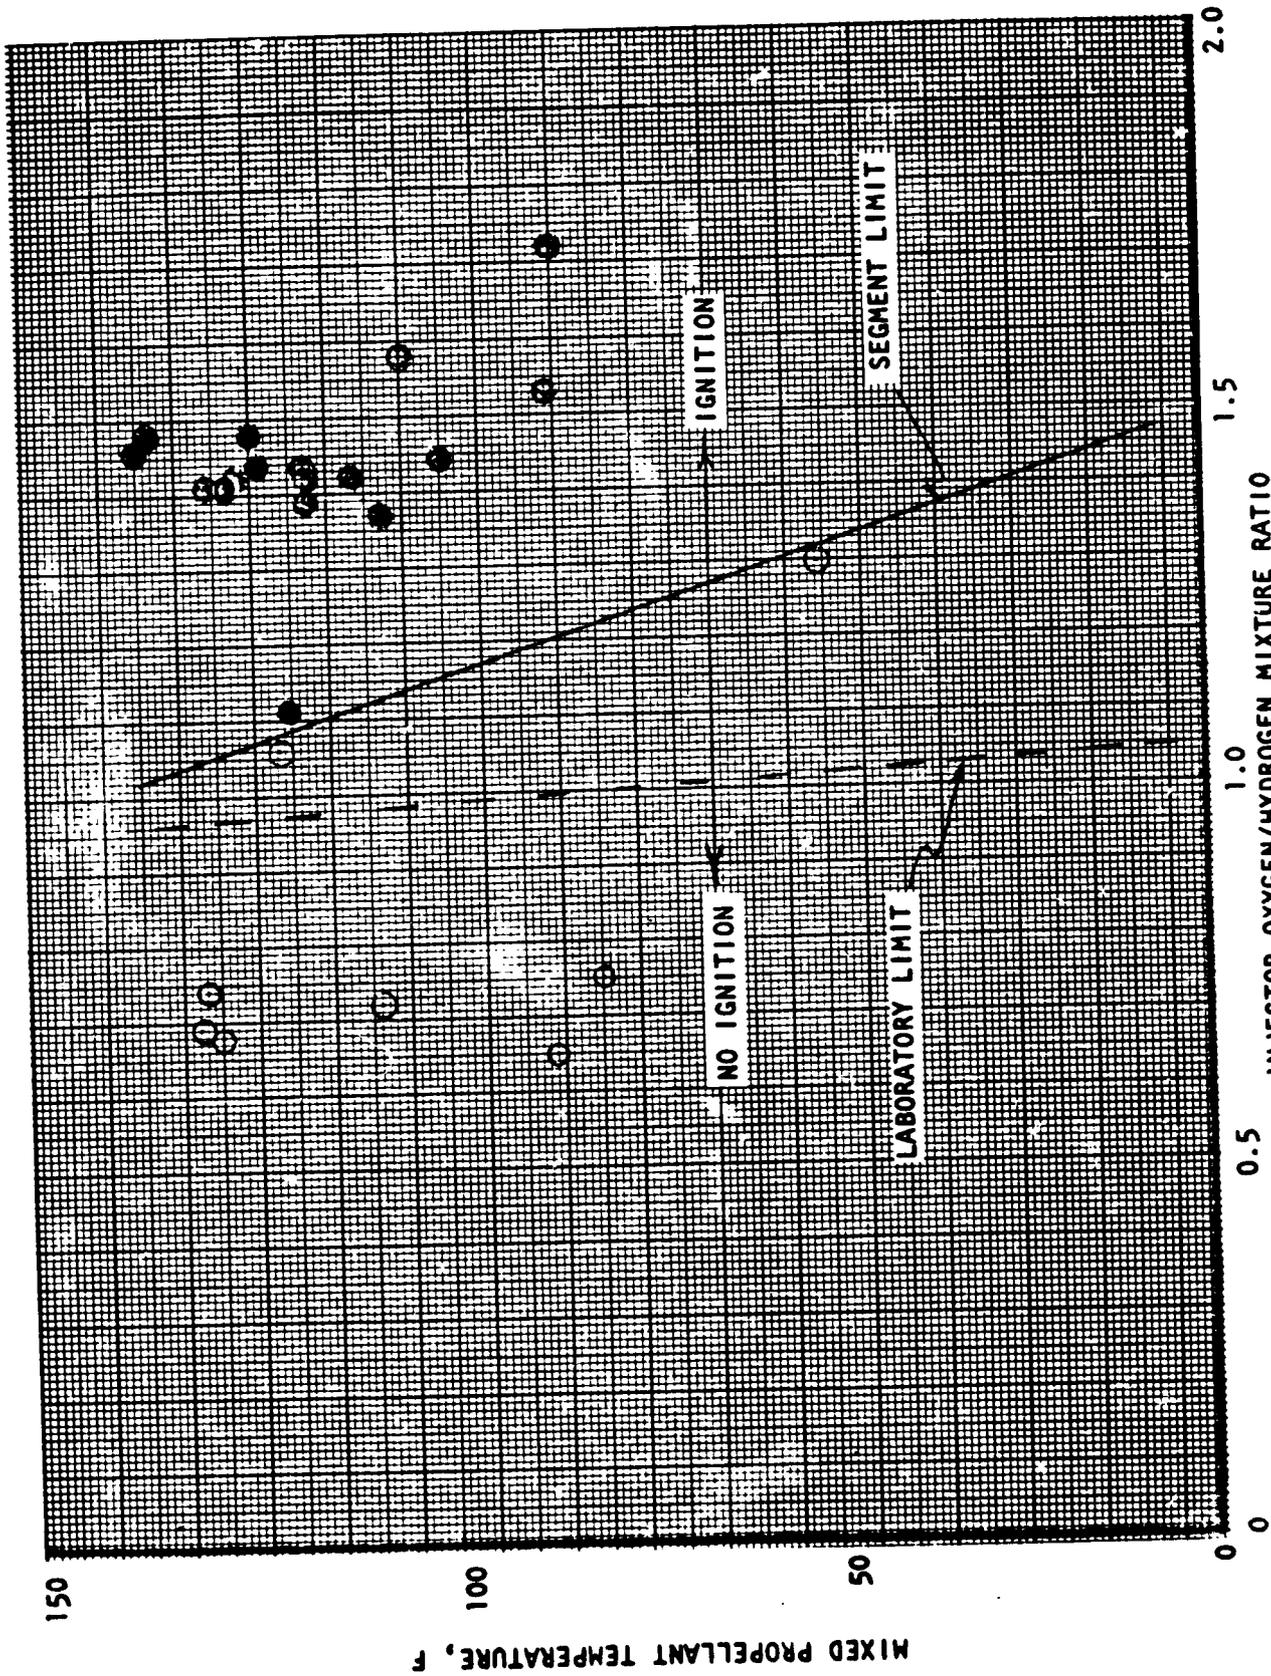
Figure 86. Fluorine Ignition, Oxygen/Hydrogen Ignition Limits

A comparison of the multisegment ignition limits with established laboratory ignition results is presented in Fig. 86. The difference between the segment limit and the laboratory limit for well-mixed, static gas is attributed to incomplete mixing in the outer zones of the segment injector elements. Five additional tests were conducted to evaluate the effect of a gaseous oxidizer-lead start in improving the initial heat transfer rate to the ignition-detect thermocouples, in providing a more energetic ignition transient, in eliminating the open air detonations sometimes associated with the fuel-lead start, and in establishing a cross-ignition capability for unignited segments. The oxidizer-lead ignition sequence was successful in accomplishing all the desired ignition goals and was selected as the fluorine ignition sequence for test bed No. 1. The oxidizer lead resulted in instant main propellant ignition when fuel reached the main injector, and the ignition-detection thermocouples responded rapidly at an increased rate. Cross-ignition was accomplished at mixture ratios exceeding 1.25, and no open-air detonations were experienced. No hardware damage or overheating resulted from the sequence.
